Building Envelope
Systems Specialist:
Klepper, Hahn & Hyatt

Owner:
Syracuse University

Location:
Syracuse, NY

Watson Hall Exterior Masonry Repair

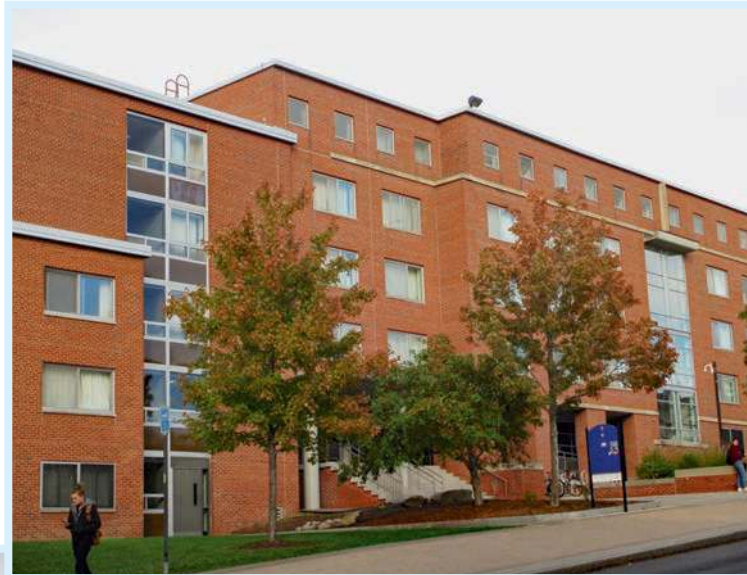
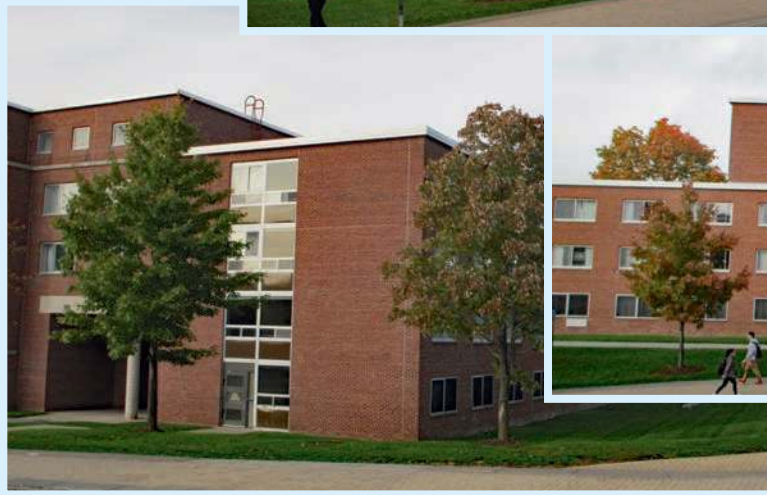
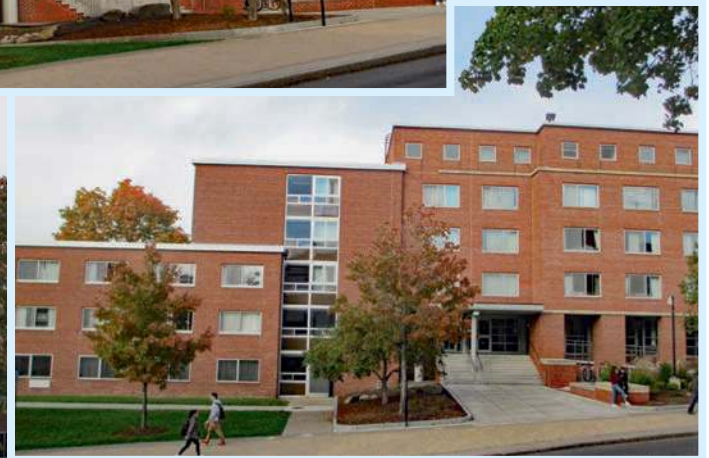
This project was initiated to correct observed façade masonry issues and repair distressed areas. These areas included cracks in the face brick, crashed limestones, open weathered joints of the veneer elements, face bricks shifted off the steel lintels, deteriorated parapets, and deteriorated concrete canopies.

The majority of the problems in the façade masonry were because of brick expansion and the lack of movement joints. The parapets deteriorated because of moisture infiltration through failed joints. Moisture also penetrated the concrete canopies and created an environment conducive to steel rusting and concrete jacking.

Corrective measures included providing additional vertical and horizontal movement joints, replacing aged sealant, saw cutting existing joints that were bridged with mortar and not performing properly, replacing damaged face brick areas and individual bricks, repointing open masonry joints, replacing or repairing damaged limestones, and replacing damaged glass block units. Where the expanded face brick shifted outward, steel angles were extended, and the steel was painted where indicated. Helical masonry ties were installed to insure anchoring of those expanded areas to the CMU backup.
