**Building Envelope  
Systems Specialist:**  
Klepper, Hahn & Hyatt

**Owner:**  
Colgate University

**Location:**  
Hamilton, NY

## Alumni Hall Masonry Facade Repair

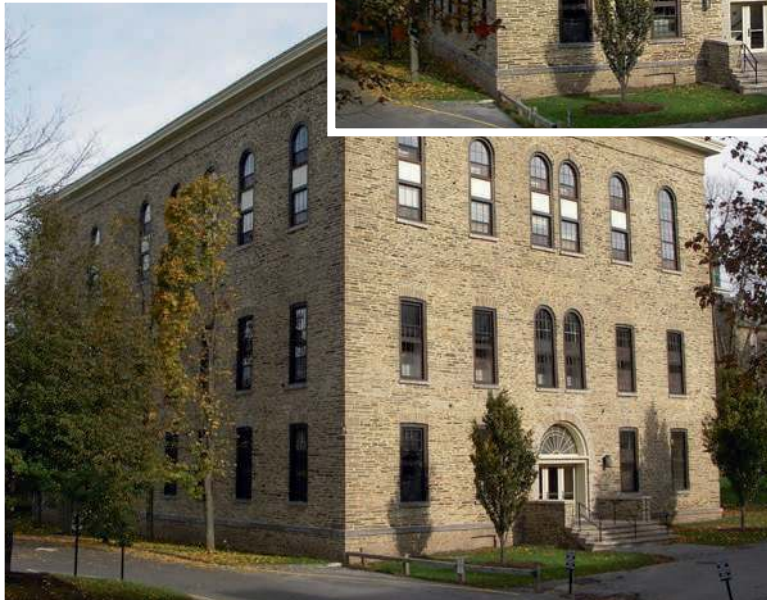
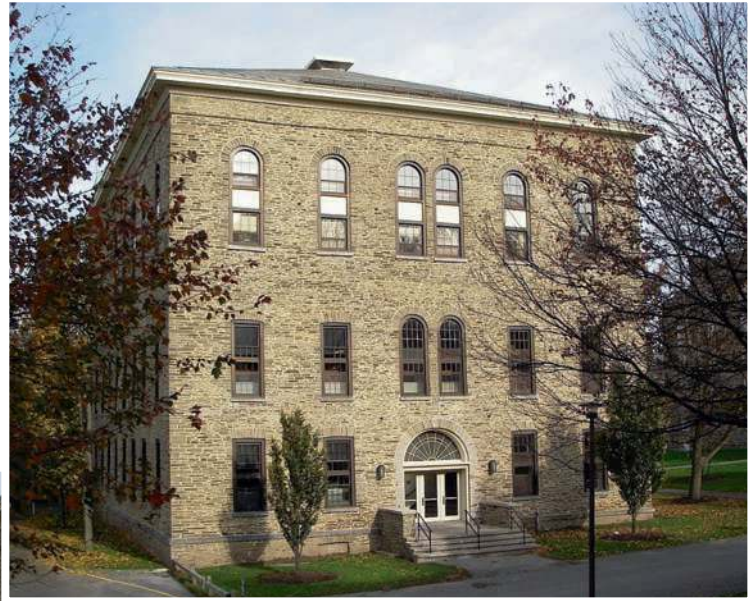
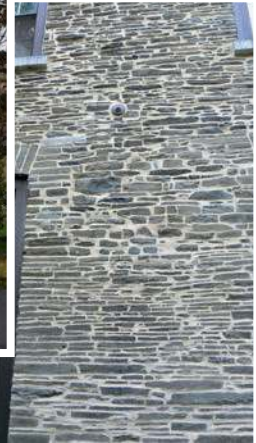
Upon casual review the façade appeared to be in good condition. The building had been repointed in the 1960s with a very hard Portland mortar that appeared to be intact. Upon closer inspection, the façade exhibited numerous bulges, wall cracks, and broken stone sills. Once the pointing mortar was removed, it became apparent that the original lime mortar was deteriorated eight to twelve inches deep within the 24-inch thick walls in many areas of the building. The deterioration was caused by freeze/thaw damage to the interior mortar facilitated by moisture trapped behind the dense Portland mortar. Removal of all Portland pointing mortar was recommended. It was replaced with a mortar that matched the strength and appearance of the original lime putty mortar. This greatly lightened the color of the walls and restored the building to its original appearance.

The bulges in the wall had been caused by deep mortar deterioration and the loss of compressive strength, resulting in a buckling façade. KHH removed the deteriorated mortar and injected the walls with a flowable lime mortar that filled the voids and solidified the walls with minimal reconstruction.
