Structural Engineer:
Klepper, Hahn & Hyatt

Owner:
Dark Island Tours, Inc.

Location:
Dark Island, Chippewa, NY

Singer Castle Cast Stone Restoration

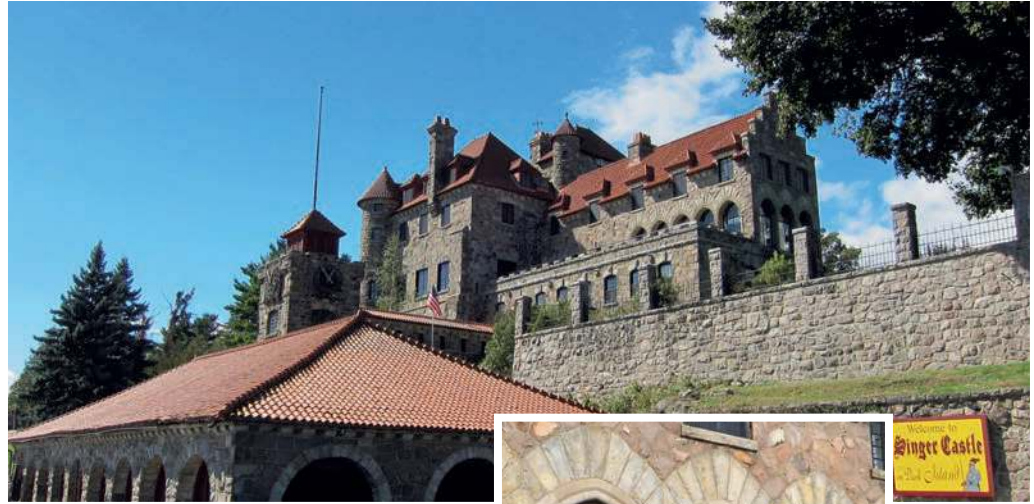
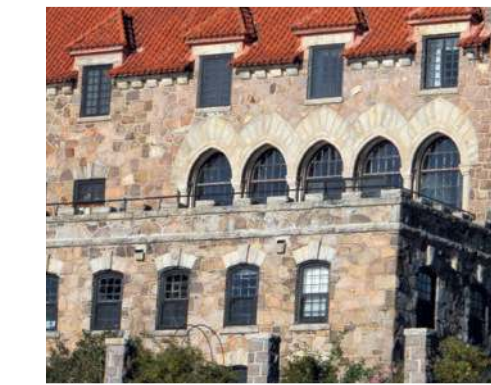
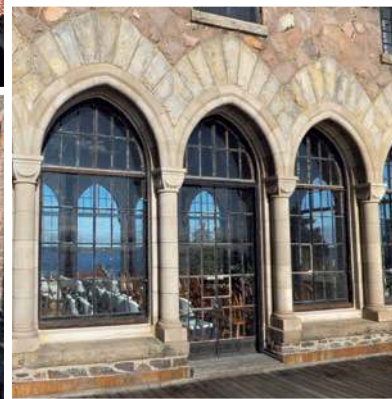
A sun room and a master suite, added circa 1912, was supported on decorative pre-cast columns and arches. The columns and arches supporting this addition were exhibiting serious deterioration around the sun room. The cast stone was delaminating in approximately two-inch thick sheets. These elements were suffering from extreme freeze-thaw damage due to the porosity of the cast stone. The deterioration of these elements threatened the structural integrity of the building. Since Singer Castle is open to the public, the owner wished to restore the facade in a manner that matched the original design of the historic property.

A petrographic analysis described the cast stone as a “simple cement mortar mixed with a low water content that is crudely mixed and poorly consolidated.” The cast stone had a relatively high compressive strength but was extremely porous, allowing it to absorb an excessive amount of moisture. The cast stone also did not contain air entrainment, which is typically used in exterior concrete to prevent freeze-thaw cracking and deterioration. Because of the continued freeze thaw damage to the inner cast stone, it was unrealistic to assume patching or waterproofing would eliminate moisture intrusion. Thus the cast stone elements at Singer Castle had to be replaced.

For this replacement, high-quality, natural limestone paired with standard type N mortar was used. To replace the cast stone, the masonry above the arches needed to be shored and supported. The contractor, working closely with Jay Saylor, P.E., of Herrick-Saylor Engineers in Pittsford, New York, created a method to do this using a tree-like mechanism with supporting branches that temporarily transferred the vertical load to the support. This allowed the masons to remove and replace the damaged cast stone while protecting both the interior and the exterior of the building from damage.
