Structural Engineer and
Building Envelope Specialist:
Klepper, Hahn & Hyatt

Owner:
SUNY Upstate Medical University

Location:
Syracuse, NY

SUNY Upstate Medical University Computer Warehouse Building Reskinning

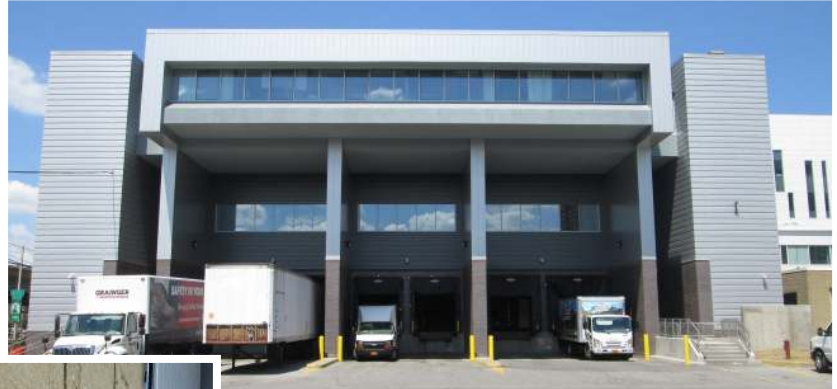
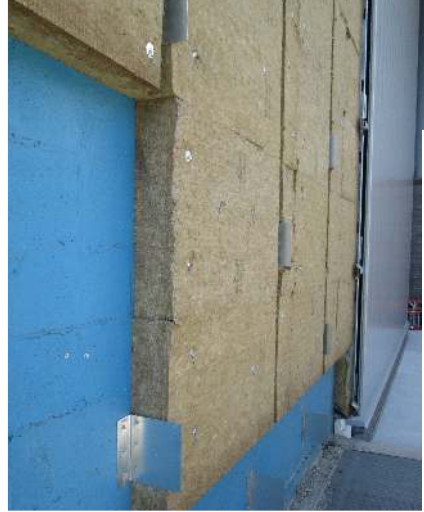
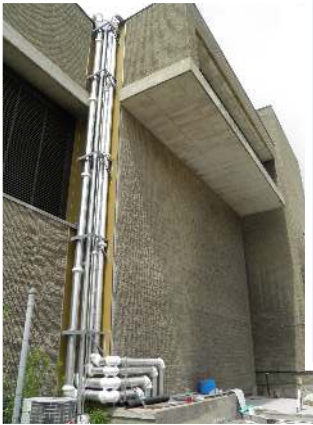
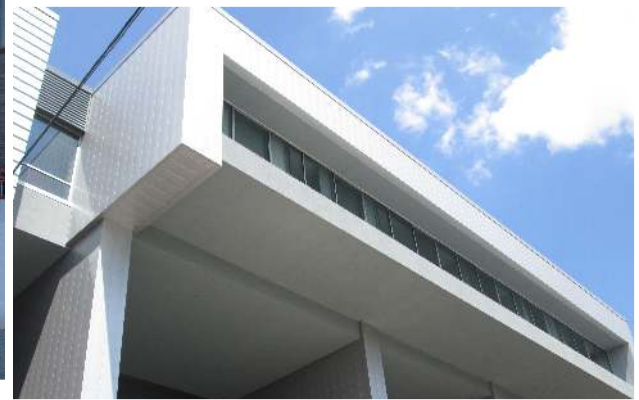
Top & Bottom Right: Completed Reskinning
Bottom Left: Conditions Prior to Reskinning
Bottom Center: Application of Rockwool Insulation

Klepper, Hahn & Hyatt served as the Envelope and Structural Consultant for this SUNY Upstate project. The original building, built in 1968, was Brutalist-style with a stack-bond split-face concrete block façade that was literally falling apart due to masonry joint deterioration and corrosion of the steel bed joint reinforcing, which doubled as ties for the exterior wythe.

The final selection was a combination masonry and metal panel system veneer over rock wool insulation, with new thermally resistant windows, a properly installed spray-applied liquid air barrier, and enclosure of the truck loading dock area. This system met the challenges of the building's unique form and configuration while significantly improving its energy performance, reducing operational costs, improving indoor thermal comfort, and creating an attractive and aesthetically appropriate contemporary upgrade to the exterior appearance of the building.
